# Surface features of chromium alloyed carbon steel specimens after salt-spray tests in NaCl solution

The most common corrosion testing procedures use flat test coupons fabricated from a given steel material. However, workpieces that undergo machining and finishing, especially those with complex geometry, may be more subject to surface degradation on their curved surfaces. In the long run, this may adversely affect the smooth operation of the tested component. This study investigates surface features of machined and finished chromium alloyed steel specimens with rather complex geometries. Changes in several important surface features (topography, roughness, cylindricity, chemical degradation rate and corrosion products) were all measured periodically (after 24, 96 and 192 hours) on several sets of manufactured carbon steel planetary axle specimens exposed to a chemically aggressive medium (aqueous NaCl spray) at 35 °C. In the neutral salt spray (NSS) testing cabinet the cylindrical parts of the chromium alloyed carbon steel shafts showed quite severe and uneven chemical degradation, with the formation of several iron oxide-hydroxide products (rust) observed together with some chro

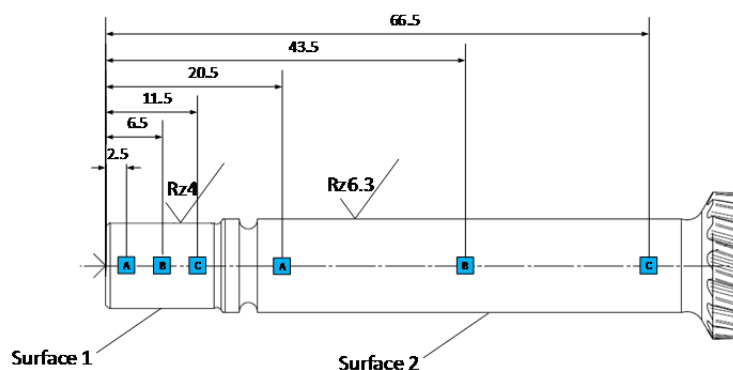
Fig. 2 Surface roughness measurement positions on the rod parts of the tested planetary axle

A simplified drawing of the tested part of the given planetary axle is shown in Figs. 1 and 2. The surface finishing of the manufactured rods was made by grinding to roughness values of Rz4 and Rz6.3 (Fig. 2).

Surfaces of the samples were analysed by an Altisurf© 520 three-dimensional surface topography measuring machine. This equipment has three different measuring heads: an inductive gauge, an LH-G32 laser sensor and a CL2 confocal chromatic sensor (CCS) with an MG140 magnifier. The most accurate measuring head, the CSS sensor was used in the current investigations, as it can measure surface roughness of the order of 5nm [14]. Three measurement positions were defined on each section investigated (A-C, Fig. 2), and the measurements were performed in three angular positions at 120° from each other. The three angular positions were marked on the face of the rod. Thus, 18 profiles and 18 surfaces were recorded for each surface. Surface 1 has a roughness specification of Rz4, while Surface 2 has a more permissive tolerance of Rz6.3.

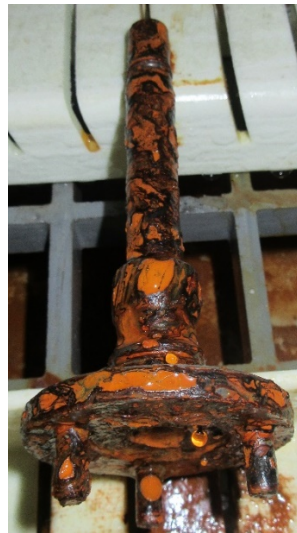
**Fig. 3** Specimen (steel planetary axles) positions in the NSS chamber equipped with air flow operating aqueous salt spray nozzles

In a neutral salt spray (NSS) testing chamber the specimens are exposed to a highly corrosive environment where tiny and fresh solution droplets (salty fog) continuously arrive to and wet the solid surface, maintaining a more or less coherent aqueous NaCl solution film containing dissolved oxygen as well. In such an artificial environment, which is somewhat similar to natural windy situations with precipitating salty water droplets close to the sea, carbon steel specimens start corroding according to the well-known electrochemical reaction mechanism that is thoroughly described, for example, in a recent review article of Alcántara *et al.* [16]. Namely, in the aqueous salt solution containing dissolved oxygen, there will be migrating tiny local anode and cathode sites with iron dissolution (oxidation to iron ions) and oxygen reduction, respectively. Then the iron(II) and iron(III) cations can react with the anions (first of all OH<sup>-</sup> anions) present nearby with the formation of soluble and non-soluble oxide-hydroxides and other corrosion products depending on the actual local electrochemical reactions and physical transport circumstances (diffusion, solution flows, etc.). In the NSS chamber operated at the Corrosion Testing Centre of Starters E-Components Generators Automotive Hungary Ltd., the specimens were placed parallel to each other (Fig. 3), and the operational parameters listed in Table 2 were used.

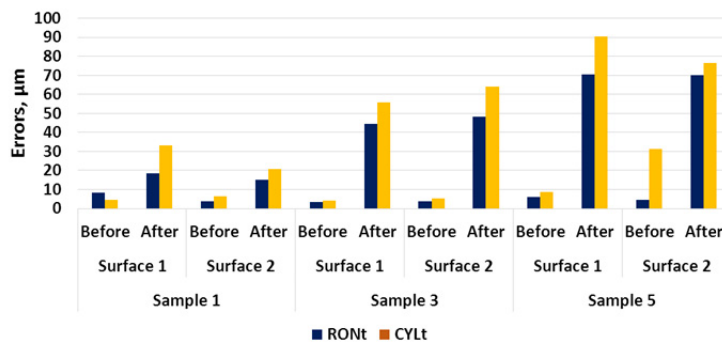
**Fig. 8** Change in RONT roundness total error and CYLt peak to valley cylindricity deviation parameters for the 96-hour salt spray cycle time for various samples

The data from Table 5 shows that the longer the duration of the salt test was, the greater the value of the circularity error and the cylindricity deviation after the rust removal. This is observable on Fig. 8 as well, where the results after each test intervals are compared. Fig. 8 shows changes of RONT and CYLt parameters for the 96-hour salt spray test time for Surface 1 (A) and Surface 2 (C) for the three specimens.

Similar results can be found on the other surfaces of the examined samples. It is apparent from Fig. 8 that the measured CYLt peak to valley cylindricity deviation and the measured RONT roundness total error show very similar values, both for Surface 1 and for Surface 2. In addition, for the 24-hour and 192-hour salt spray test the deviations for Surface 1 were the greater, so further investigations are detailed only for Surface 1. Figs. 9 and 10 illustrate the relationship between the three cylindricity deviation parameters for Surface 1, as well as the three circularity error parameters and the salt spray test cycle time. It is clear that with the increase in salt spray test time, the nature of increase in both the cylindricity deviation and the circularity error is almost identical. Applying Equation (1), the deterioration factor can be calculated for CYLp, CYLv, RONp, RONT as well (Table 6).

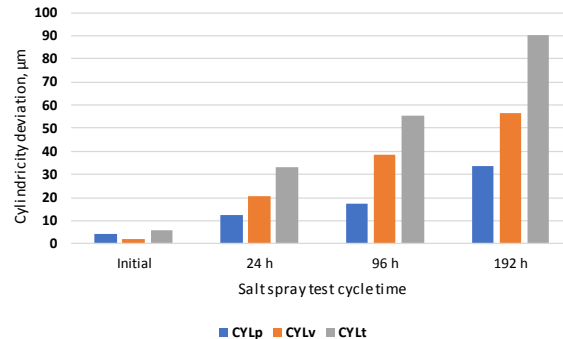
**Fig. 9** Relation between CYLp, CYLv and CYLt cylindrical errors and salt spray cycle time, Surface 1

We found that the value of the deterioration factor for CYLt becomes approximately 3.1 times higher when the salt spray test time was 192 hours related to the value which resulted at 24 hours. This ratio is approximately 5.2 when examining the RONT circularity error parameter.
