Advances in Production Engineering & Management
Volume 21 | Number 2 | June 2026 | pp 268–275
https://doi.org/10.14743/apem2026.2.573

Premature failure analysis of a high-strength hot-dip galvanized 42CrMo4 steel bolt

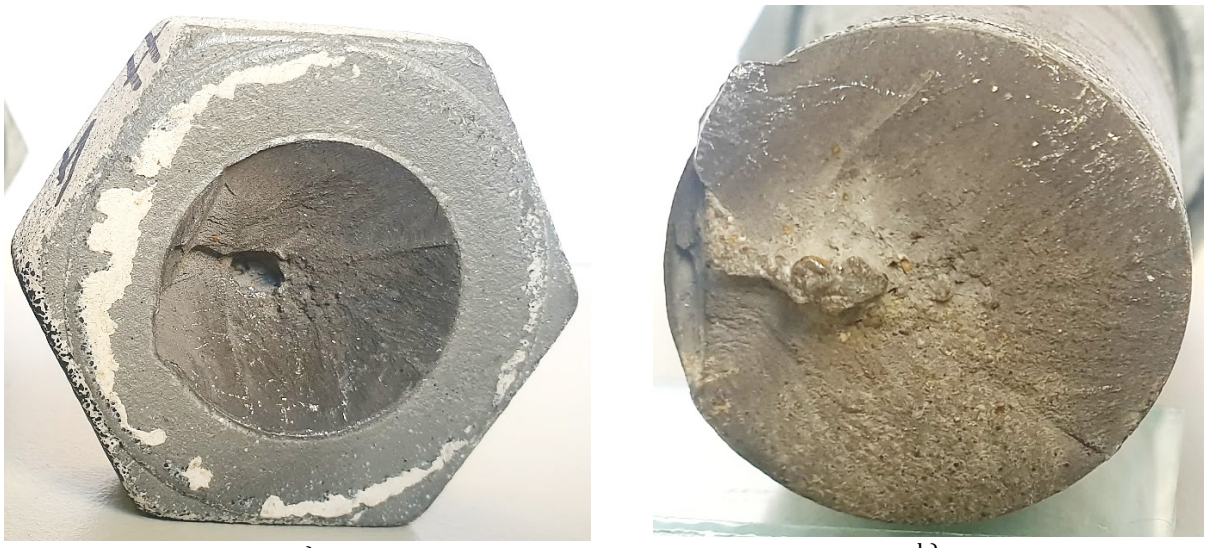
Fig. 3 shows the fracture surface of the bolt on both the head and shank. A cross-section of bolt failure shows two clearly distinct areas: a smooth area along the entire outer edge and a quasi-circular rough region located in the central part of the cross-section of the bolt. The rough, central region of the failure surface has a significantly smaller area compared to the zone of stable crack propagation. The failure is straight, perpendicular to the axis of the bolt, see also Fig. 2.

Fig. 3 Fracture surfaces on the received bolt: (a) head; (b) shank

According to the client, the high-strength class 10.9 bolt failed a few days after installation. The fracture morphology in Fig. 3 indicates that an initial crack formed at the head-to-shank junction and propagated rapidly to final failure. Considering the short time to failure, the high-strength 42CrMo4 steel, and the sequence of heat treatment and hot-dip galvanizing, hydrogen embrittlement (HE) is the most likely failure mechanism [17, 18]. Because the bolt was installed in a statically loaded structure for only a short period, fatigue is unlikely to have been the dominant failure mechanism.

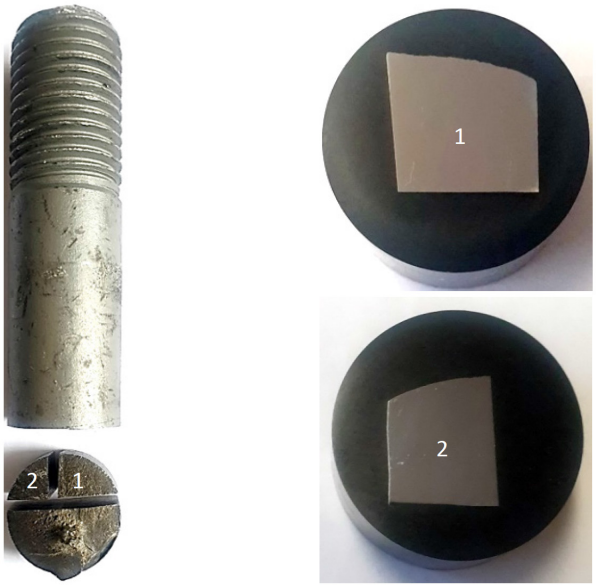
Fig. 4 shows a sectioned part of the bolt shank with the fracture surface and the mounted metallographic samples marked 1 and 2. The preparation procedure for samples 1 and 2 included grinding, mechanical polishing, and etching with 3 % nital.

Fig. 4 Sampling for microscopic analysis: (a) cutting a part of the bolt shank with a fracture surface; (b) mounted metallographic samples 1 and 2

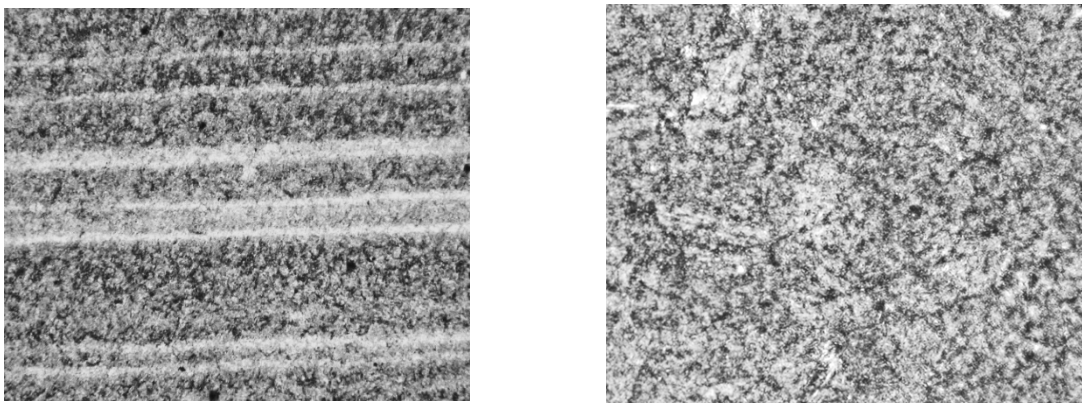
Metallographic analysis of the cross-section of the fracture surface was carried out using an optical microscope at magnifications of 100× and 500×. The microstructures of samples 1 and 2 were similar, showing banding parallel to the longitudinal axis of the bolt (Fig. 5a) and tempered martensite (Fig. 5b).

Fig. 5 Photographs of the cross-section of the fracture surface of tested samples 1 and 2: (a) banded microstructure (magnification 100×); (b) tempered martensite (magnification 500×)

Apart from carbon, which was measured below the nominal range, the chemical composition of the tested steel was within the prescribed values for grade 42CrMo4. The bolt was quenched and tempered, and its microstructure consists of tempered martensite. Banding parallel to the bolt axis was also observed; however, it was not considered the primary cause of the fracture.

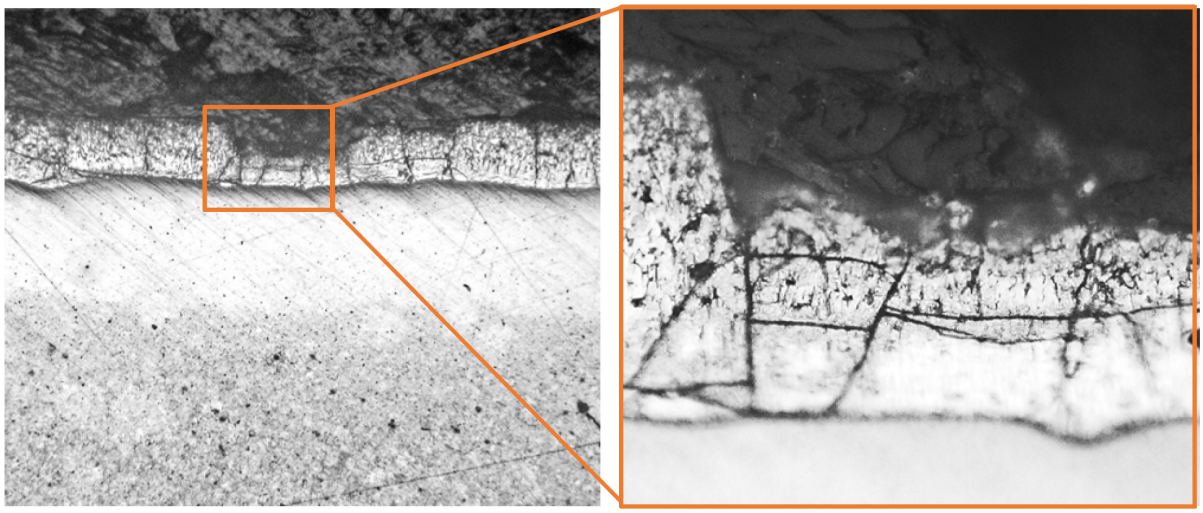
Based on microstructural examination using a measuring reticle, the thickness of the hot-dip galvanized layer was determined to be 82-155 μm. For reference, EN ISO 10684 specifies a minimum local coating thickness of 40 μm and a minimum batch-average coating thickness of 50 μm [15]. The galvanized layer was partially damaged (Fig. 6a), and cracks were also observed in the coating (Fig. 6b).

Fig. 6 Photographs of the cross-section of the zinc layer: (a) damage to the zinc layer (magnification 100×); (b) cracks in the galvanized coating (magnification 500×)

The measured coating thickness of 82-155 μm is above the minimum local coating thickness specified in EN ISO 10684 [15]. However, coating thickness alone does not establish galvanizing immersion time or hydrogen uptake; therefore, its role in the present failure cannot be determined from the available data. Cracks and microcracks in the hot-dip galvanized layer may act as local stress concentrators. In the presence of hydrogen and sustained tensile stress, such defects may contribute to susceptibility to hydrogen-assisted brittle fracture [19, 20].

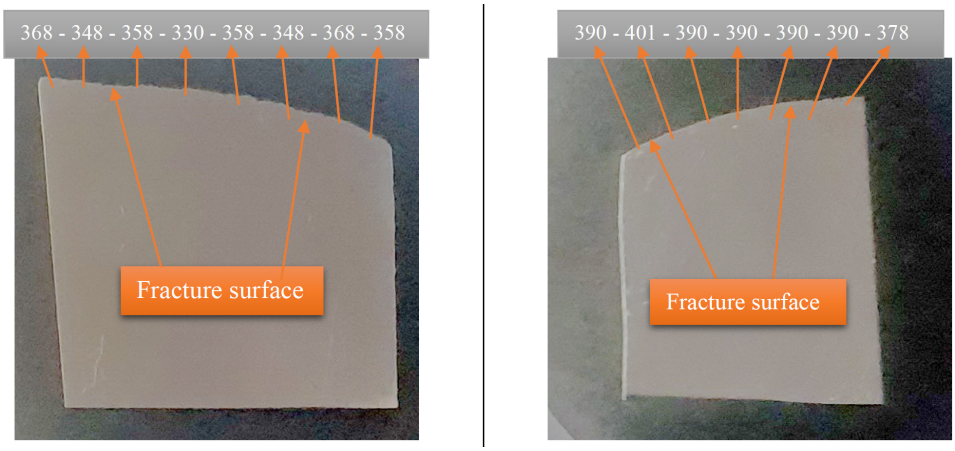
Fig. 7 Location of measurement points and measured hardness values (HV1) on mounted metallographic samples 1 and 2: (a) sample 1; (b) sample 2

Several subsurface hardness values exceeded 350 HV1, with a maximum measured value of 401 HV1 (Fig. 7). Such elevated hardness increases the susceptibility of high-strength steel to hydrogen embrittlement [4]. General guidance also identifies susceptible high-strength material, hydrogen, and sustained mechanical stress as the key conditions for hydrogen embrittlement [21]. The elevated subsurface hardness therefore indicates increased susceptibility to hydrogen embrittlement, consistent with the findings of Zafra *et al.* [22] for quenched and tempered 42CrMo4 steel. Similar delayed-failure behaviour in high-strength hot-dip galvanized bolts was reported by Artola and Aldazabal [23]. Due to equipment and sample-access limitations, high-resolution scanning electron microscopy (SEM) fractography and direct hydrogen measurement could not be performed in this study. This is an important limitation; nevertheless, the combined evidence of elevated subsurface hardness, optical metallography, coating damage, and the short time-to-failure supports hydrogen embrittlement as the most likely mechanism. Future investigations should incorporate SEM characterisation and direct hydrogen measurement to further detail the fracture micromechanisms.
